Evaluation of Heavy Haulage Impact on Road Structures

Barents Finland Case Study on HW 4

2011

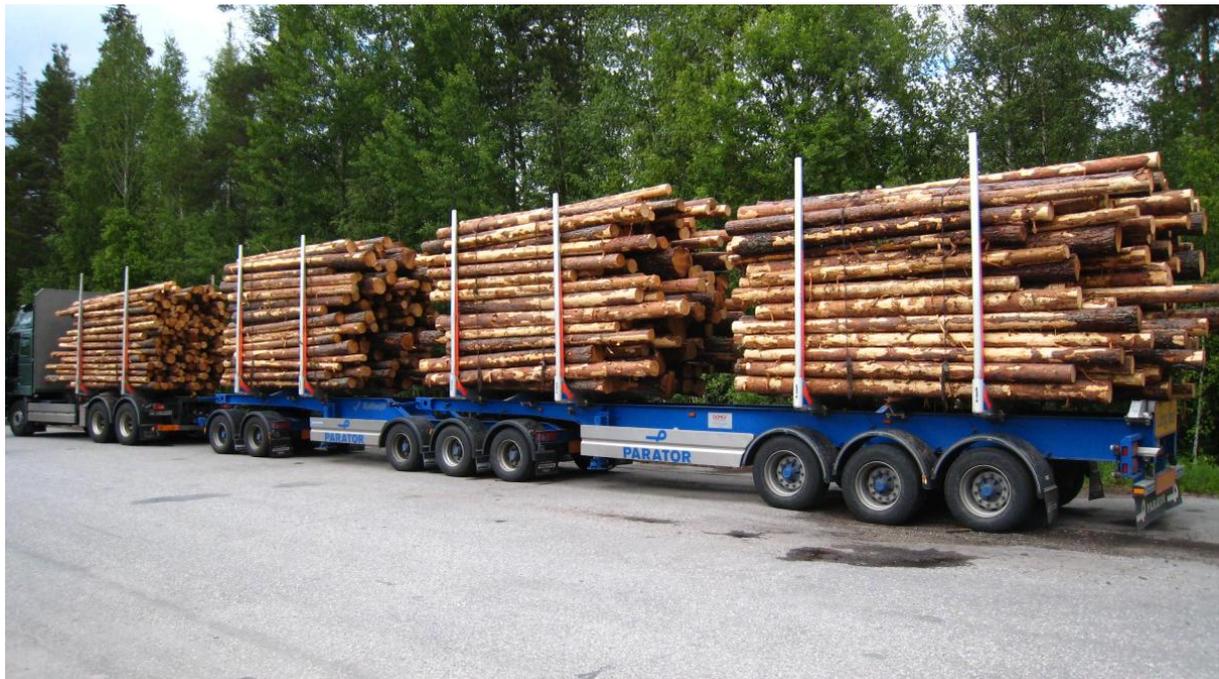
Figure 1. A 30,5 m long and 90 ton heavy truck tested in “En Trave Till” project in Northern Sweden.

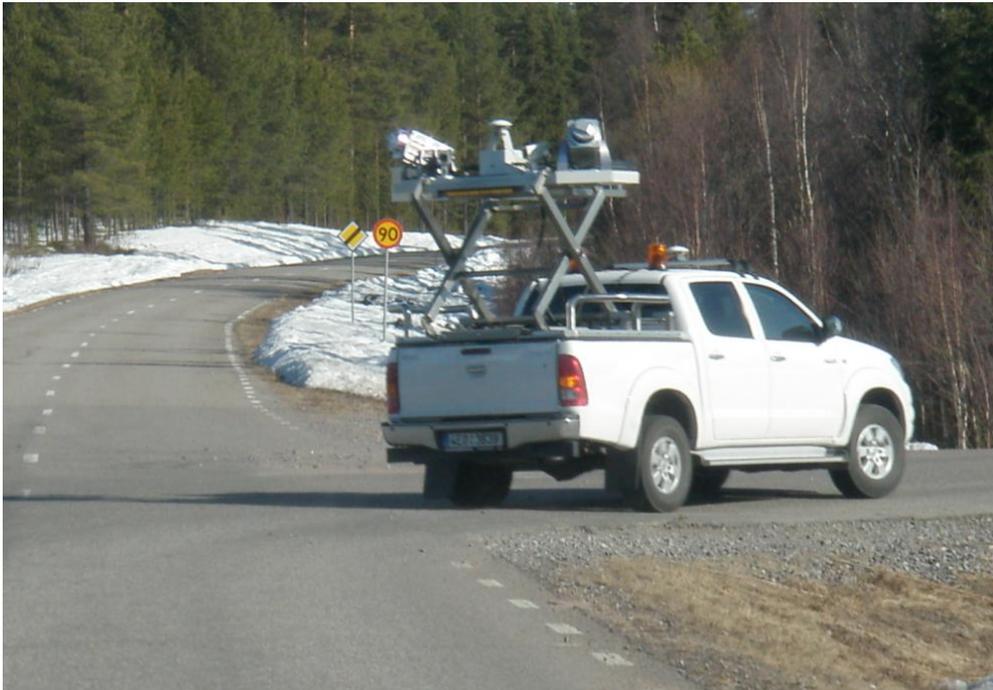
Figure 3. GEOVAP Quantum 3D mobile laser scanner vehicle in April 2011.

A mobile laser scanning survey was conducted on road section 505 by GEOVAP Ltd from Czech Republic using a Quantum 3D technique. This technique provides exact point cloud data of the road surface and its surroundings and this data can be used in road geometry analysis, road cross section analysis, drainage analysis and frost heave analysis. Because one of the main goals was to measure frost heave in the whole pavement area, section 505 was surveyed twice: first in April when there was maximum frost but the pavement surface was free of ice (figure 3). The measurements were repeated in early June after the greatest part of the frost causing frost heave had melted, but the vegetation did not disturb the measurements. The difference between the z-coordinates (height) from the two point cloud datasets produced during the two measurements was then calculated. That difference is equal to the amount of frost heave. Quantum 3D laser scanner data was also used to make an accurate map of the shape of the road surface.

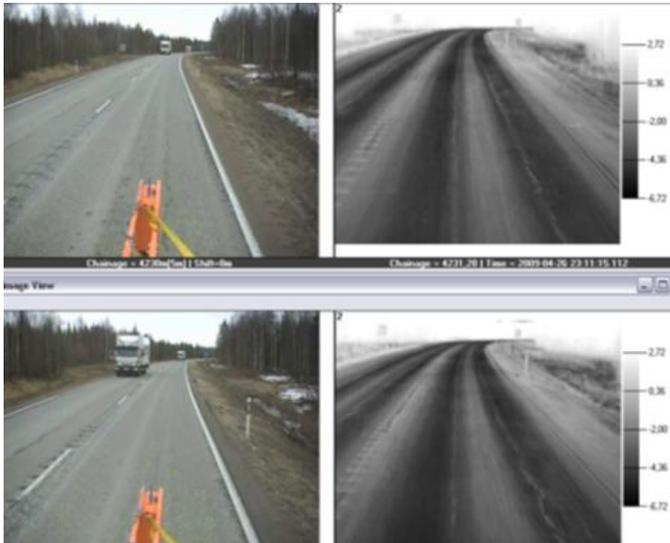
Figure 5. Digital still images and thermal camera images from HW 4, road section 505 in spring 2009. Thermal camera data shows severe top down cracking problems close to the pavement surface. Colder areas in both wheelpaths indicate water pumping through the pavement.

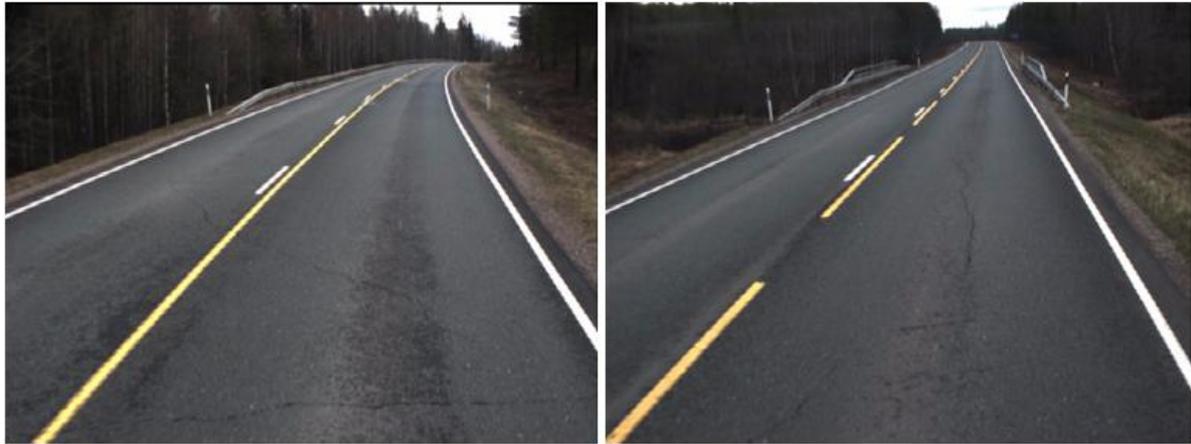
As described earlier, section 505 received a new pavement in 2010 so at the time of the analysis the pavement was only one year old. Despite this, narrow and new, and mainly frost related, transverse cracks could be detected over the whole section (figure 10). Some single longitudinal cracks could be found mainly at the end of the section (figure 10).

Figure 10. Section 505, direction 1: Left photo: 350 m. Differential frost heave related transverse cracks on side sloping ground. Right photo: 3200 m. Frost action related longitudinal cracking before the bridge.

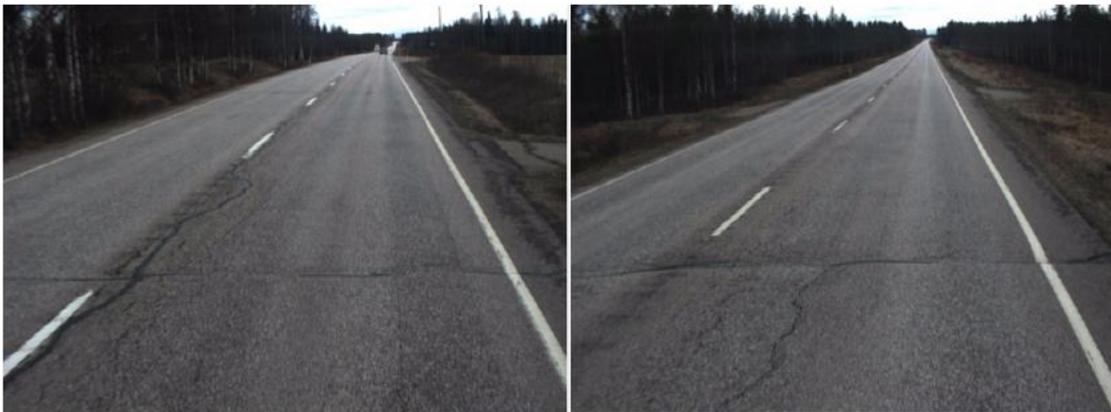
In section 515, more pavement distresses occurred than in section 505. The pavement distresses types that were found most were alligator, transverse and longitudinal cracking (table 2, figures 12 and 13). Most damaged sites appear between 1000 – 2500 m, 3000 - 5000 m and from pole 6000 to the end of the study section (figure 13).

Figure 12. Section 515, direction 1: Left photo: 4000 m. Longitudinal, transverse and alligator cracking. Right photo: 4460 m. Longitudinal, transverse and alligator cracking.

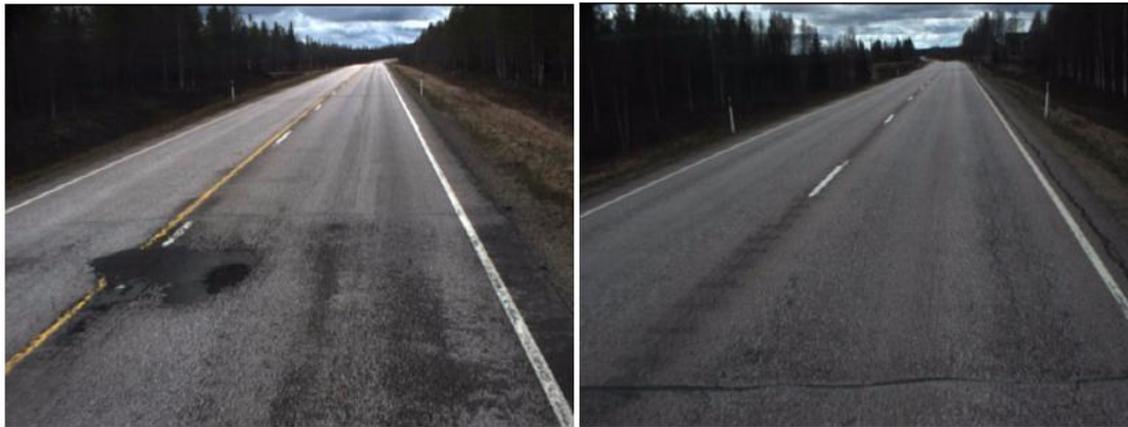
Figure 13. Section 515, direction 2: Left photo: 7000 m. Patch on the middle of the road. Right photo: 4360 m. Transverse cracking and left edge break.

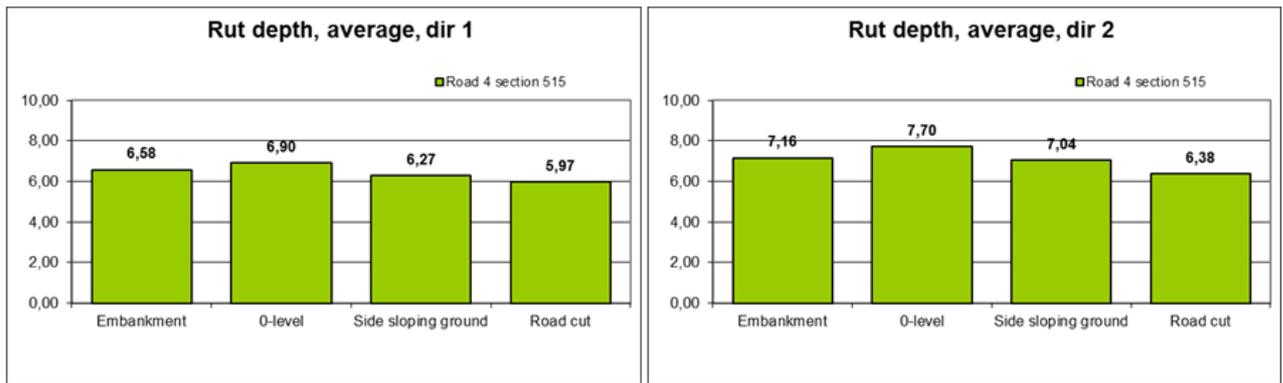
Figure 29. Average rut depth for each road profile in direction 1 (left) and in direction 2 (right).
